PRESERVING THE HERITAGE OAKS:

An Innovative Tree Root Crossing Solution For Pathways On The Wake Forest University Campus

Carolina Thread Trail Forum December 5, 2023

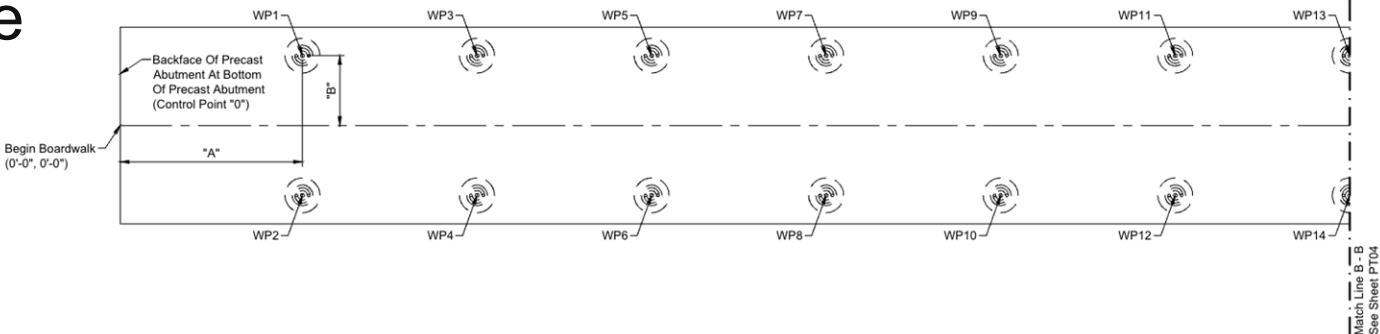
Coordination between Stimmel Associates & PermaTrak to locate tree roots and build foundation plan.

Survey of large roots + their elevations gave intel for location of support post spacing to min. impacts.

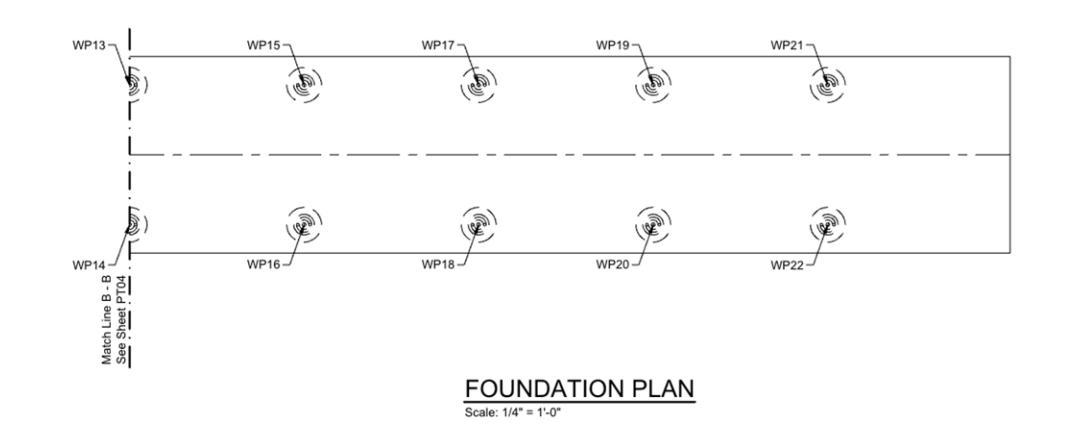
Drawings with slopes & elevations to get over tree roots

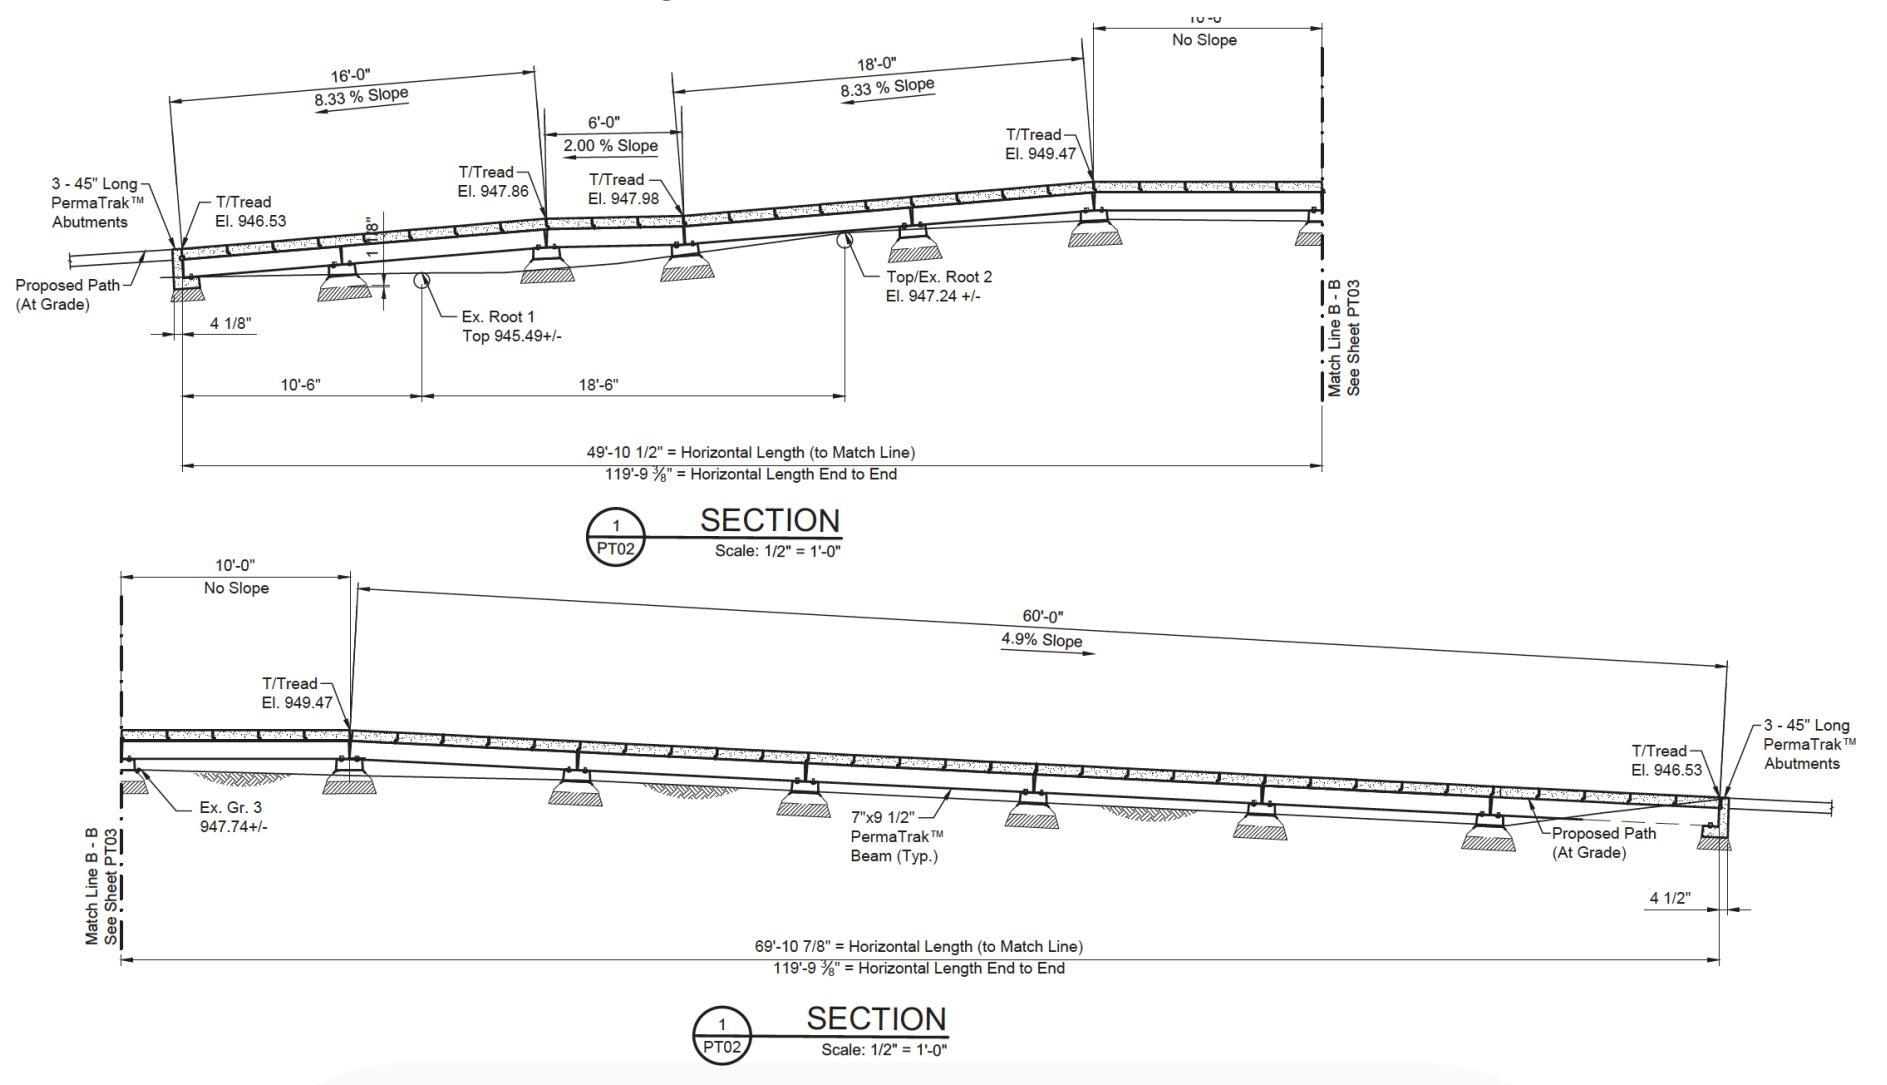
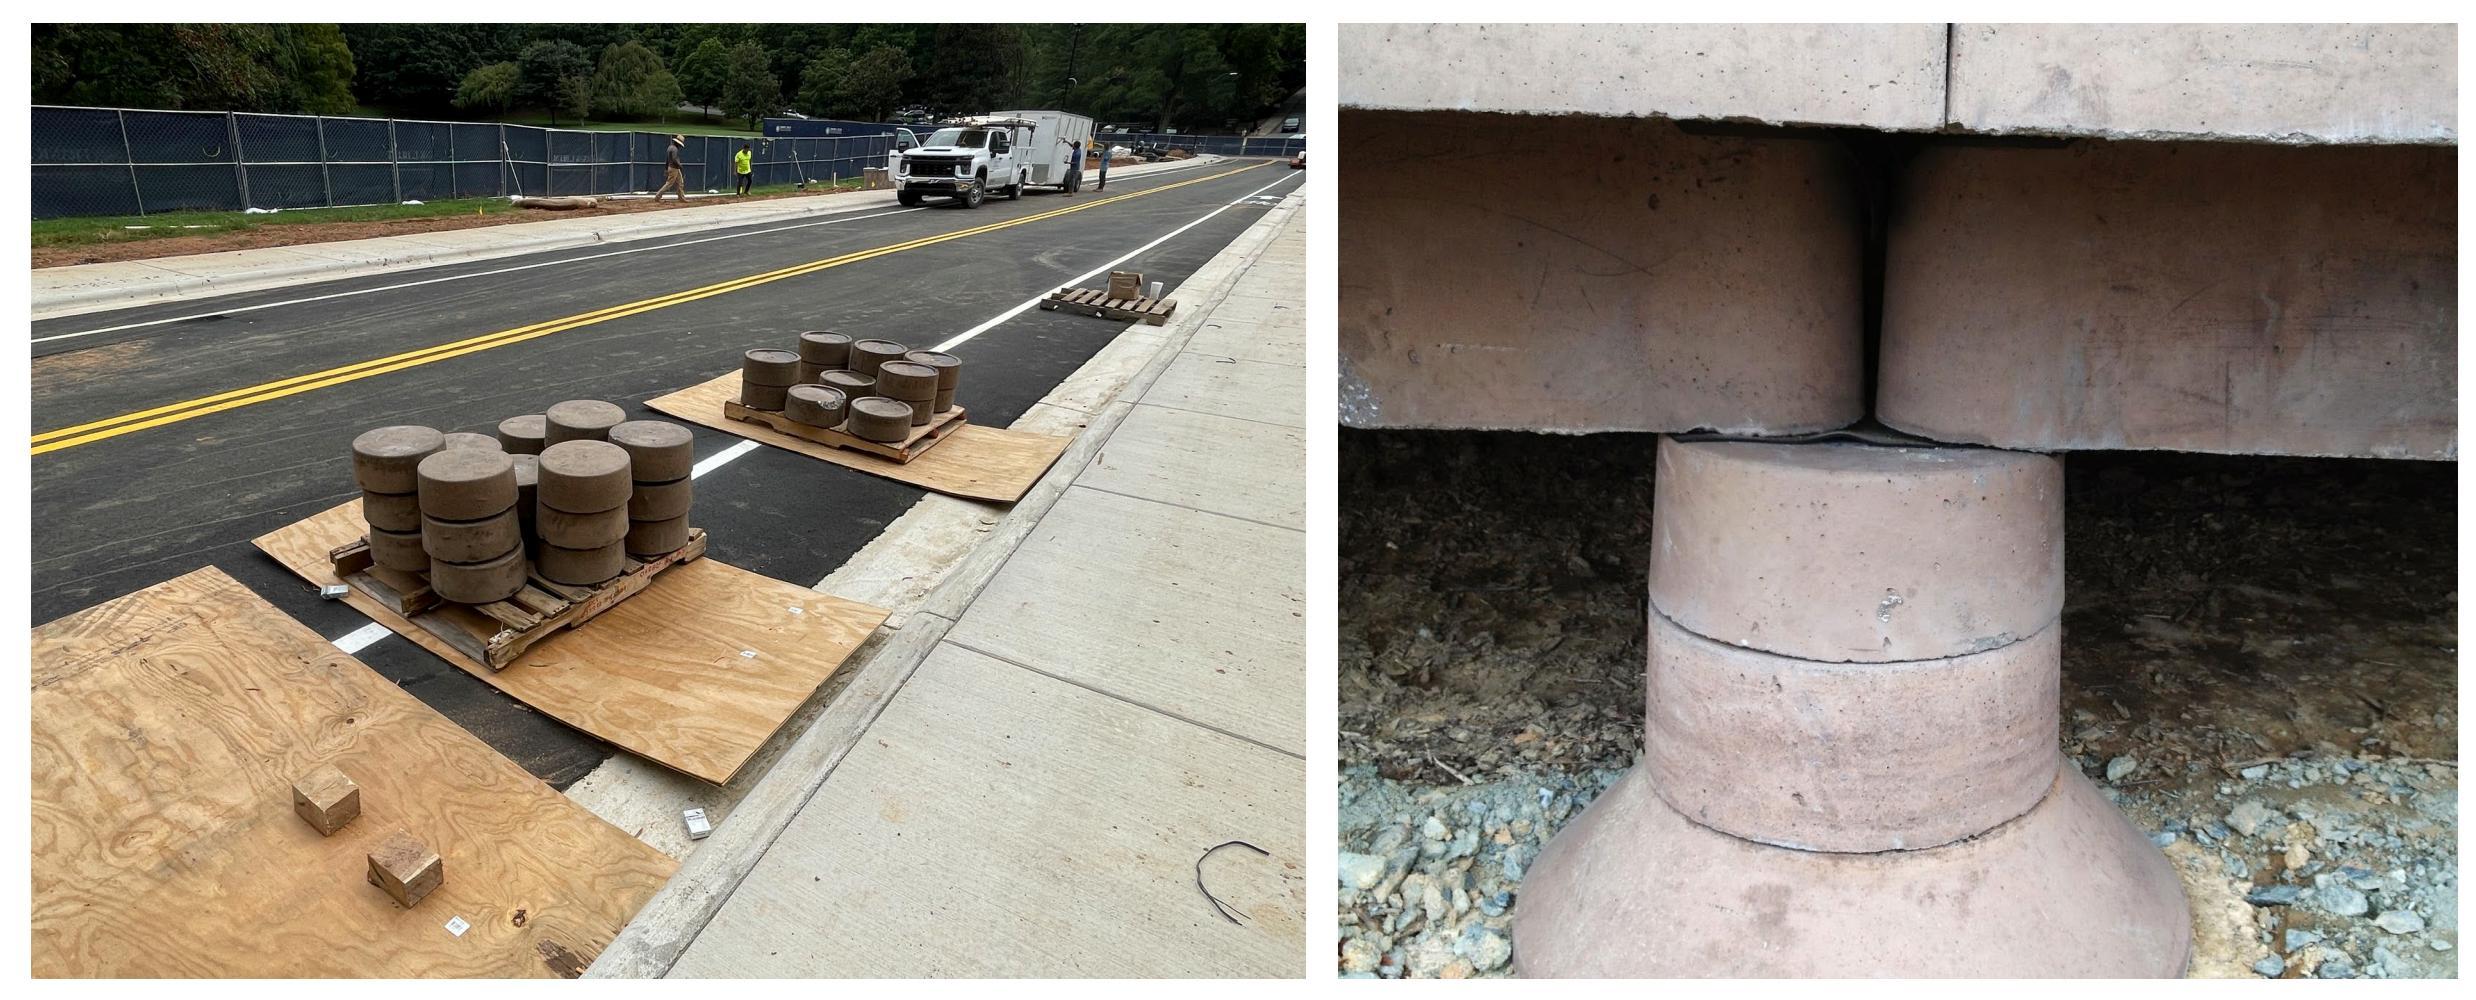
NORTH DINING HALL/ Q LOT

Railings measured & completed after construction, placement of posts onto treads for pedestrian protection. Wide 10' clearance.

ADA slopes at 8.33% maximum to traverse over roots.

Standard railing and site lighting per campus standards.

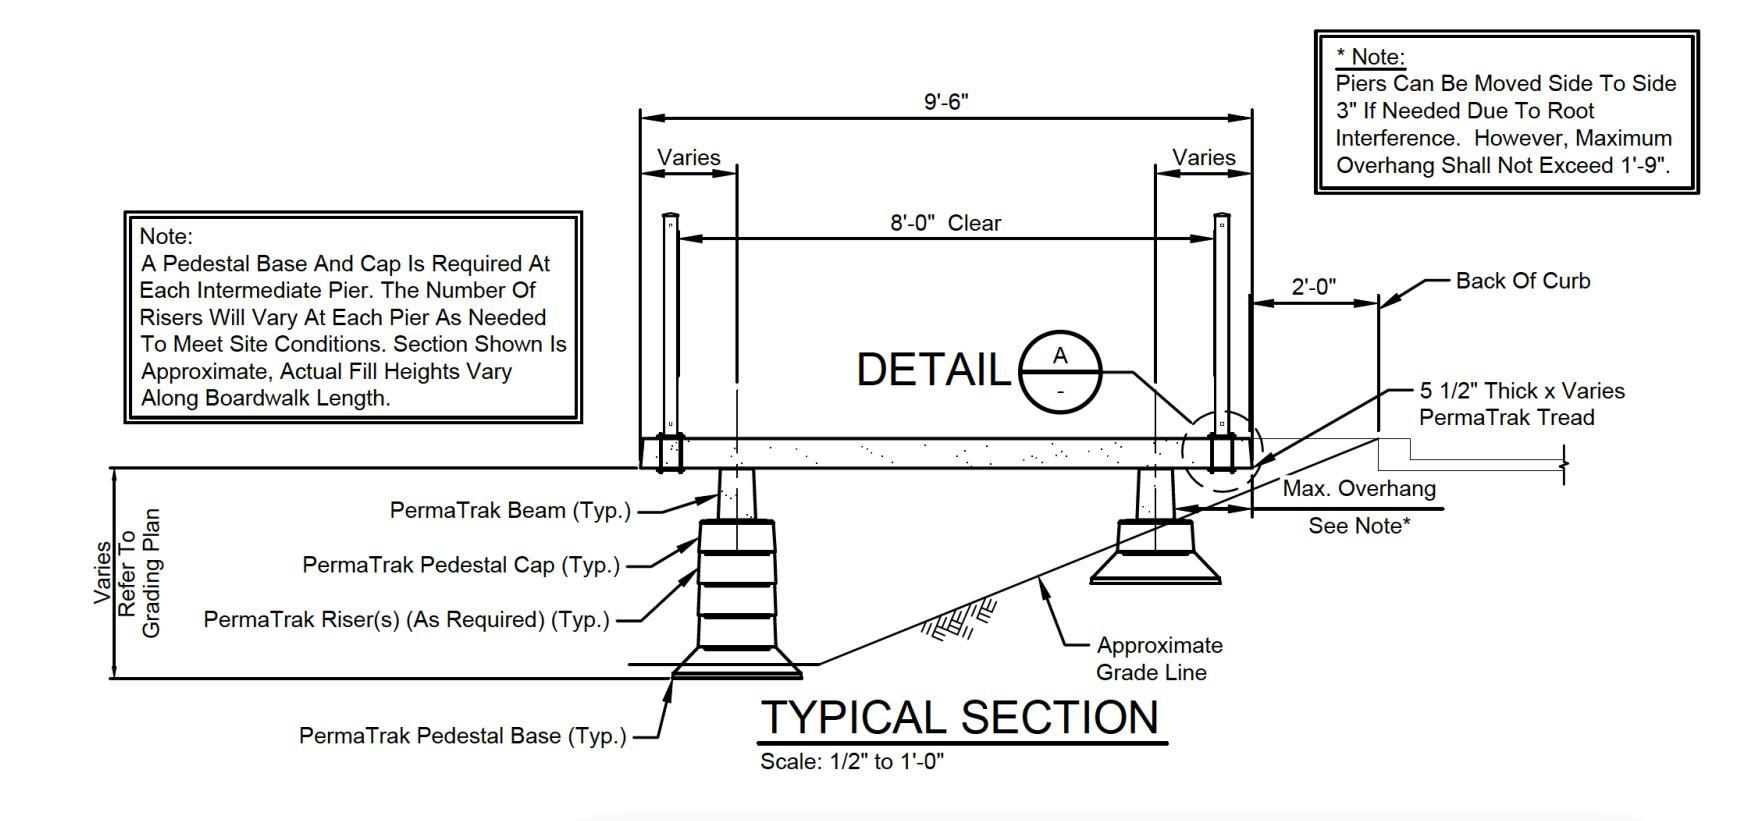
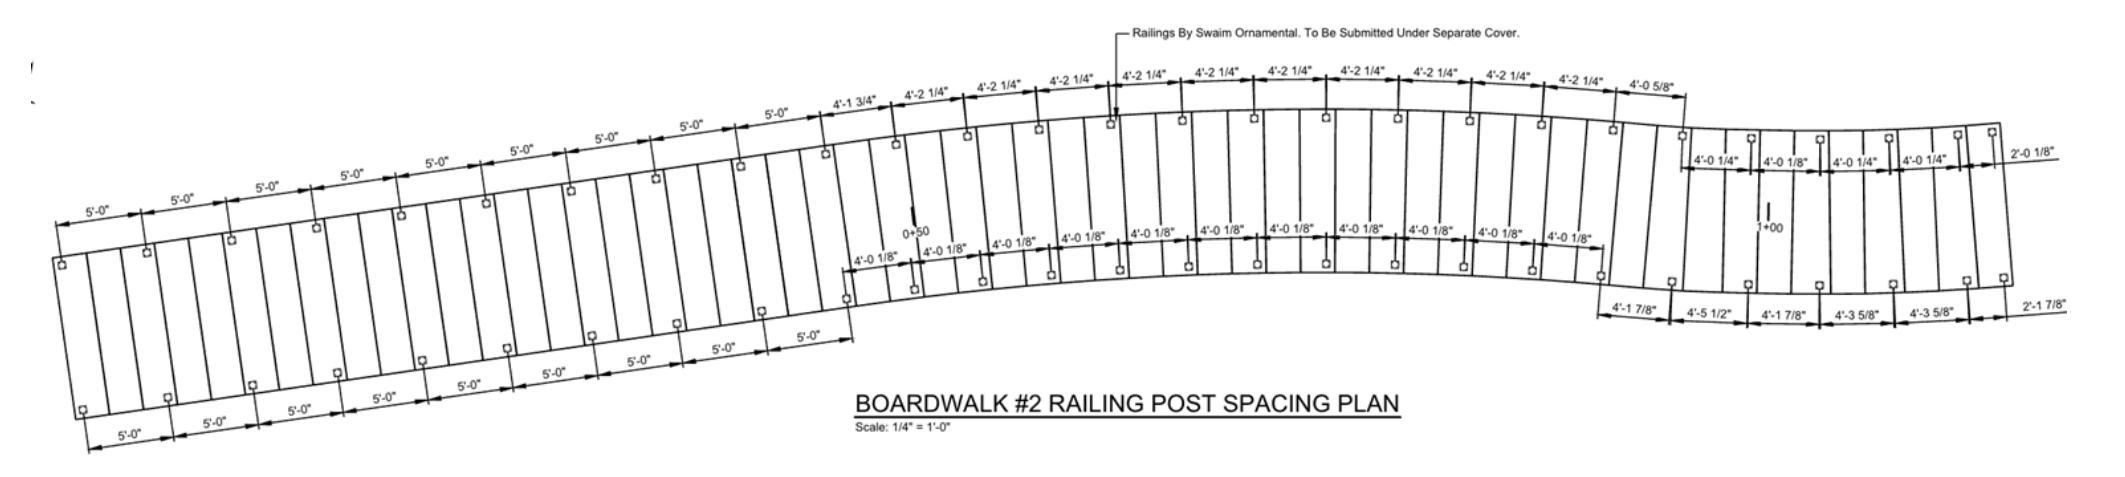
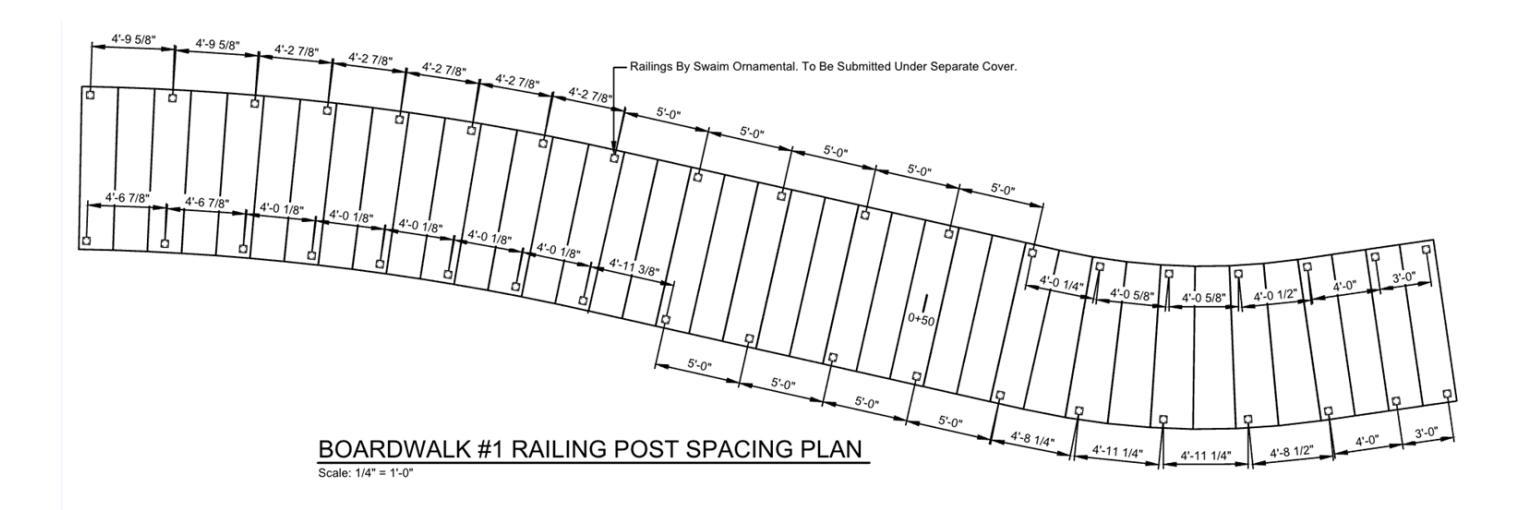
Construction Sequence

Survey

Precast piers

Field adjustments

Protection of pavement

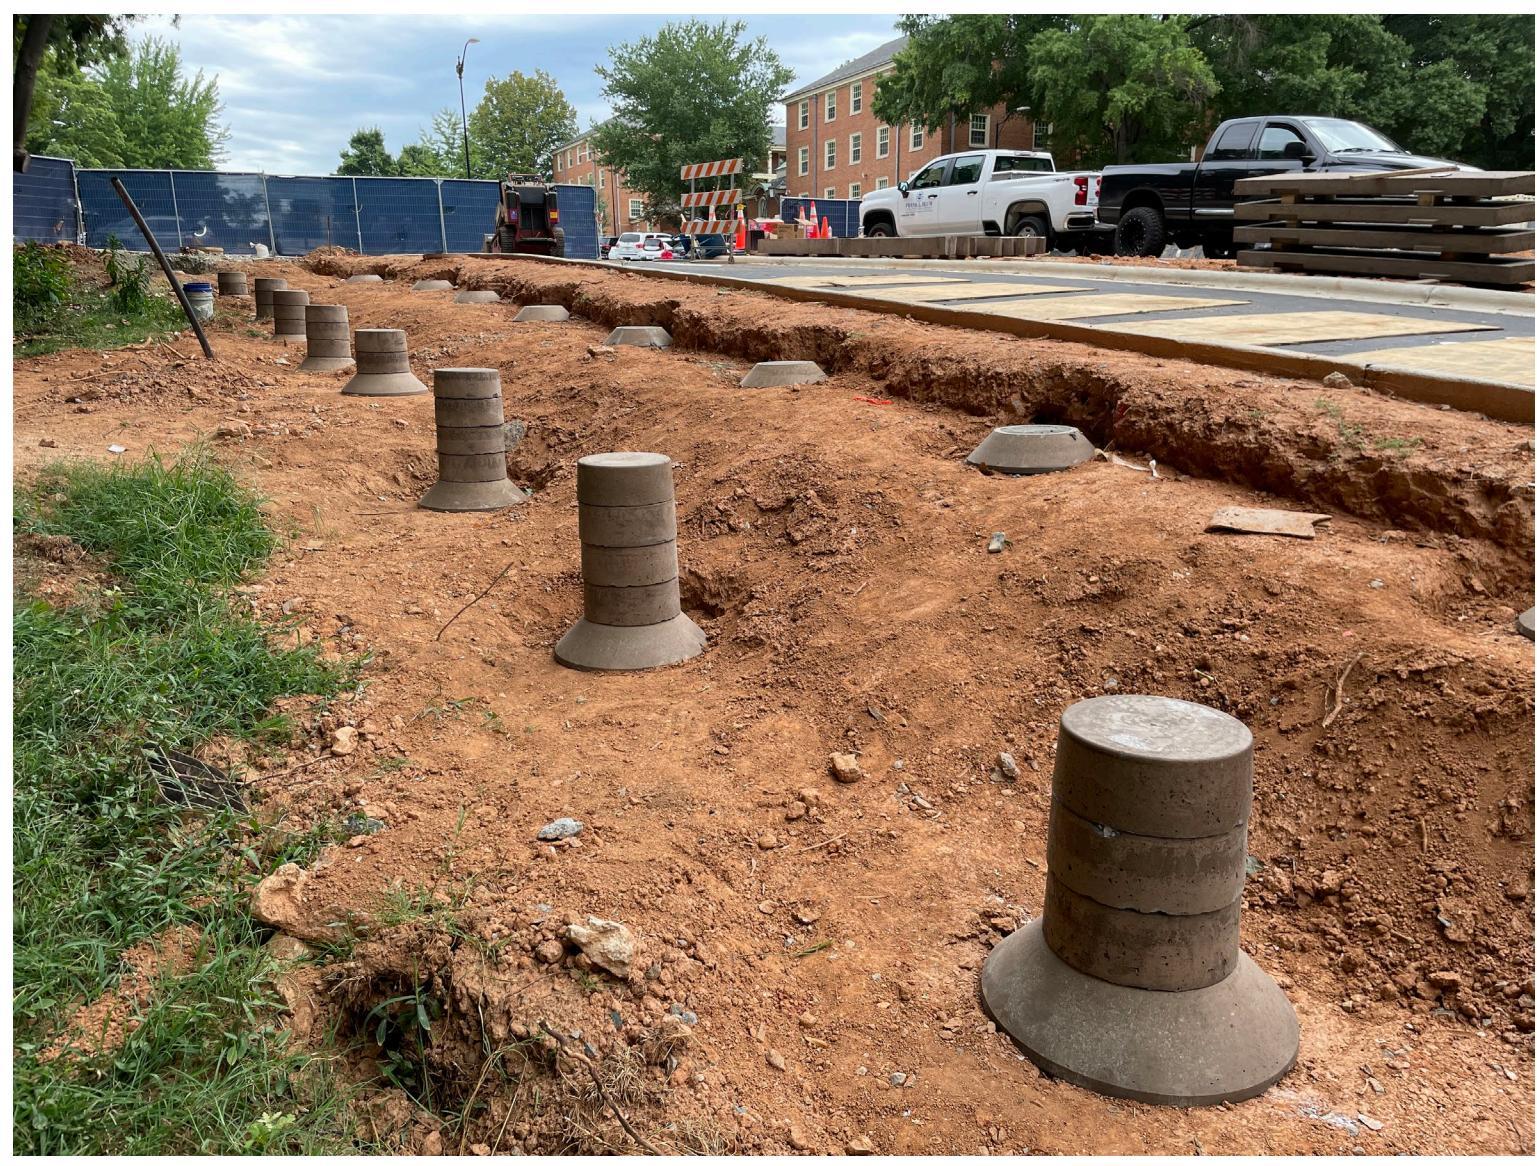
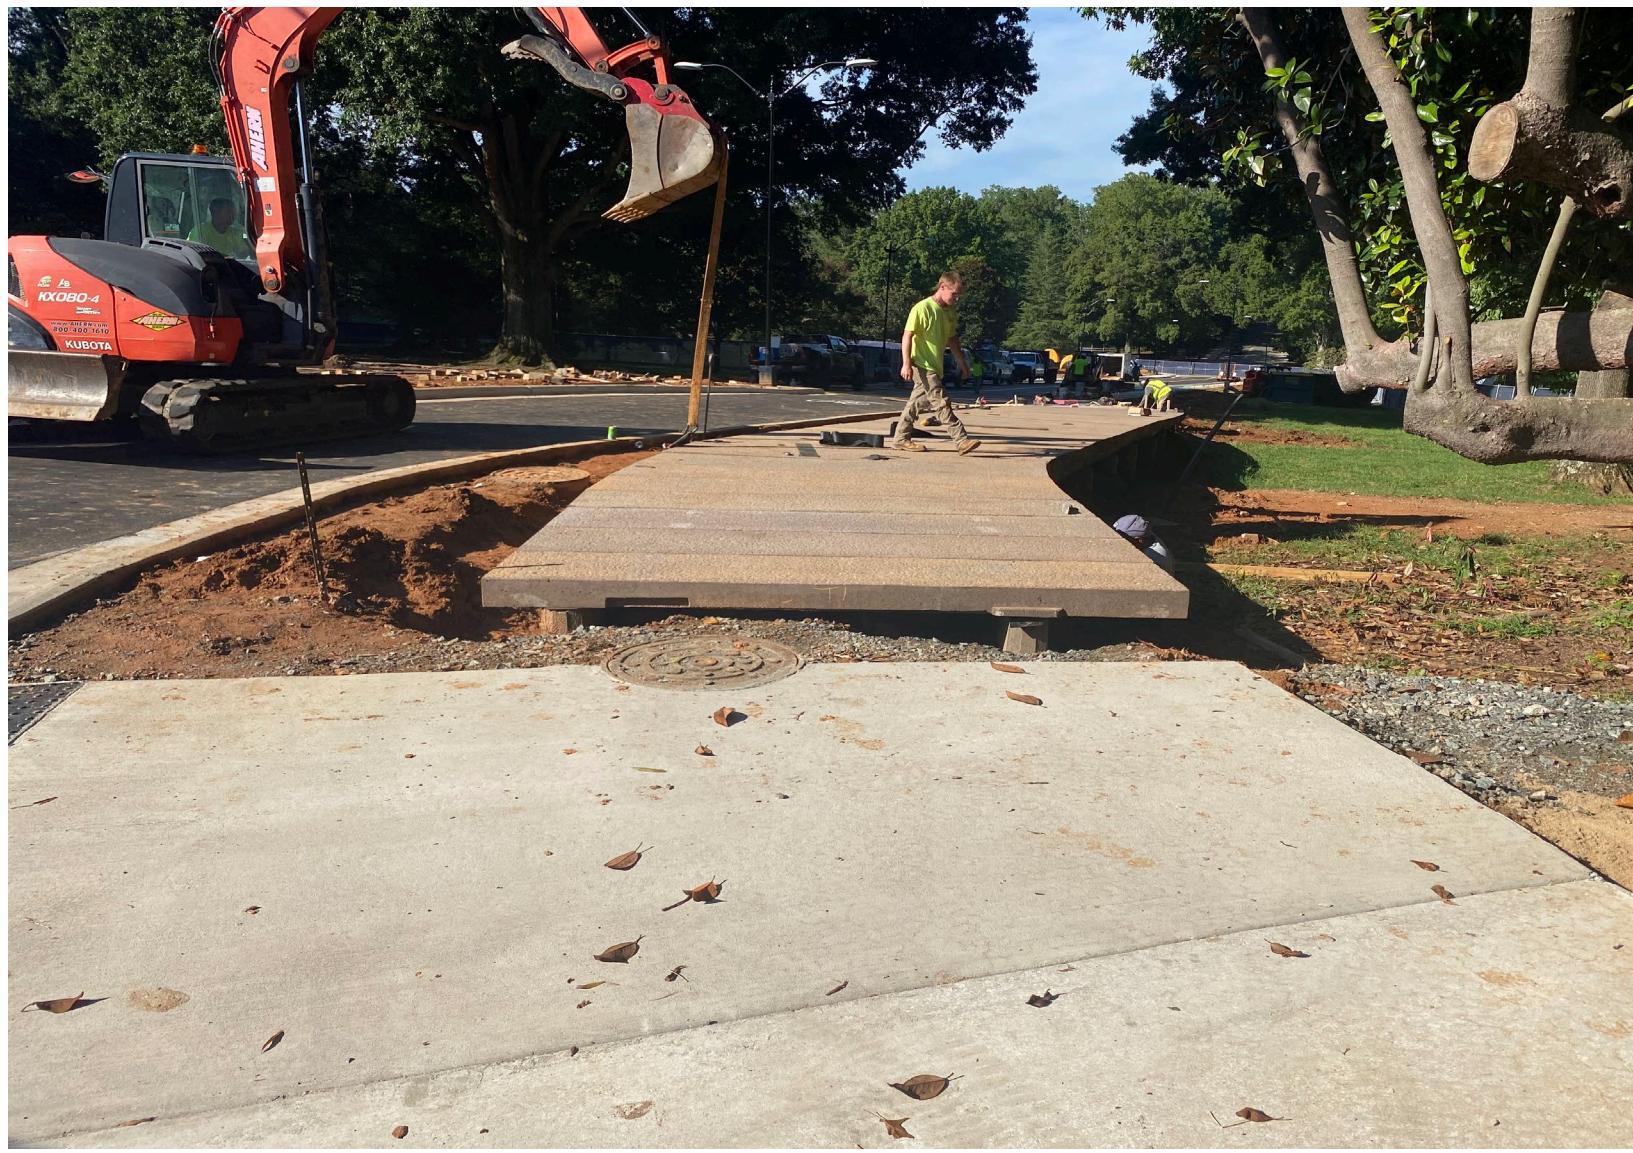
DAVIS FIELD PROJECT

Installation

Protection of Paving

Leveling of treads and Tie in with new walks.

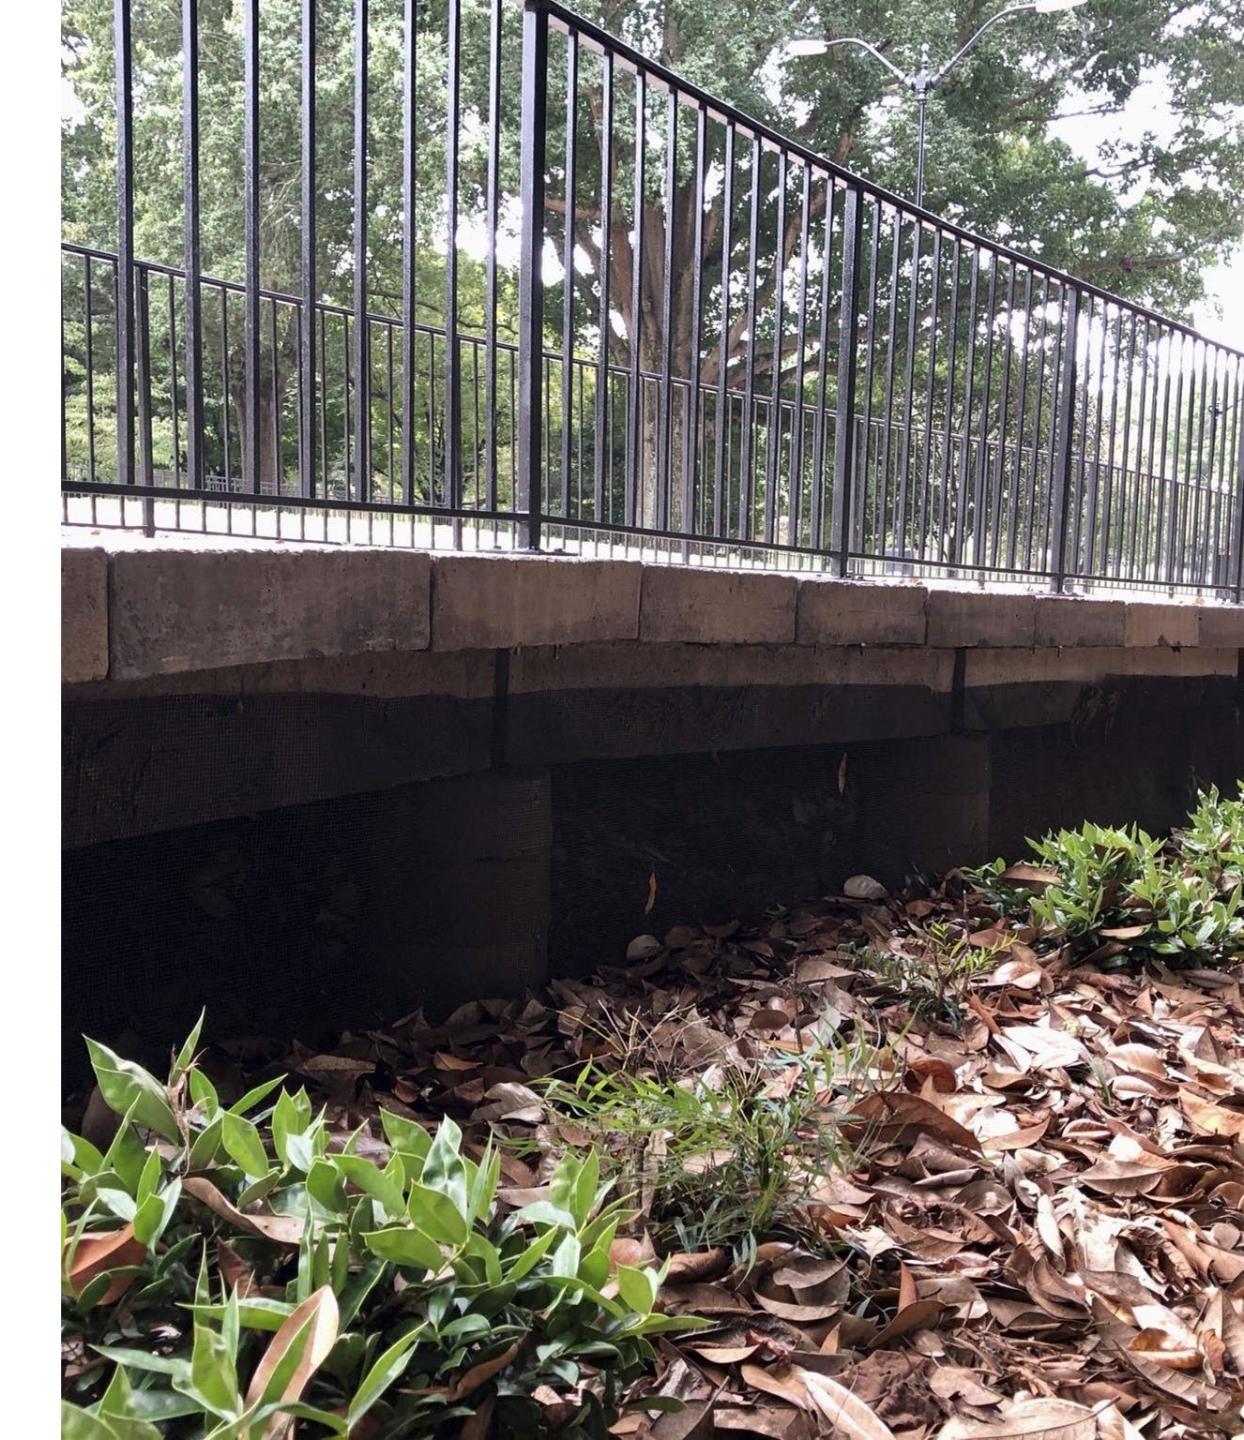
Critter Fence system with polymer fencing. Specifically this spec was for anti-climb with feral cats on campus and buried 12" min.

Shrubs were added for additional screening.
